# Manhole Inspection Summary

Manhole # S29GG1001MH

Insp Date: **12/29/06 10:34 AM**

**Location** Address: **4001 KESWICK RD**

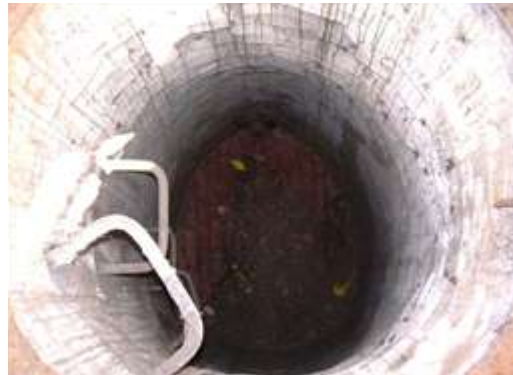
Top View

Channel debris.

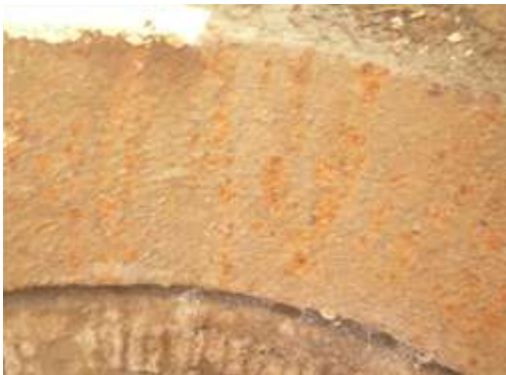
Defect

☒ **Leaks**

Frame leaks.

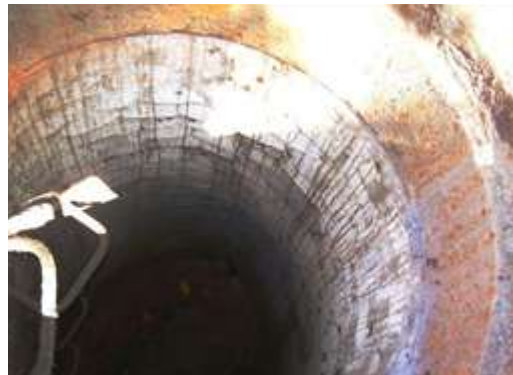
Defect

Infiltration: ☐ None ☒ **Joint** ☐ Cracks ☐ Mortar ☐ Roots ☒ **Wall**

Infiltration: ☐ None ☐ Joint ☐ Cracks ☐ Mortar ☐ Roots ☒ **Wall**

Frame leaks. Adjustment and Barrel infiltration.

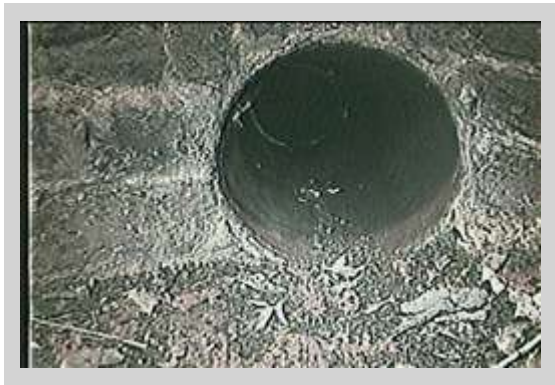
8 in. Circular Gravity Sewer  
Pipe Out @ 12 O'Clock

Infiltration: **Evidence** Pipe Seal Cond: **Cracked**
